FLIGHT MEASUREMENTS OF THE FLYING QUALITIES

OF AN F6F-3 AIRPLANE (BUAER NO. 04776)

II - LATERAL AND DIRECTIONAL STABILITY AND CONTROL

By Walter C. Williams and John P. Reeder

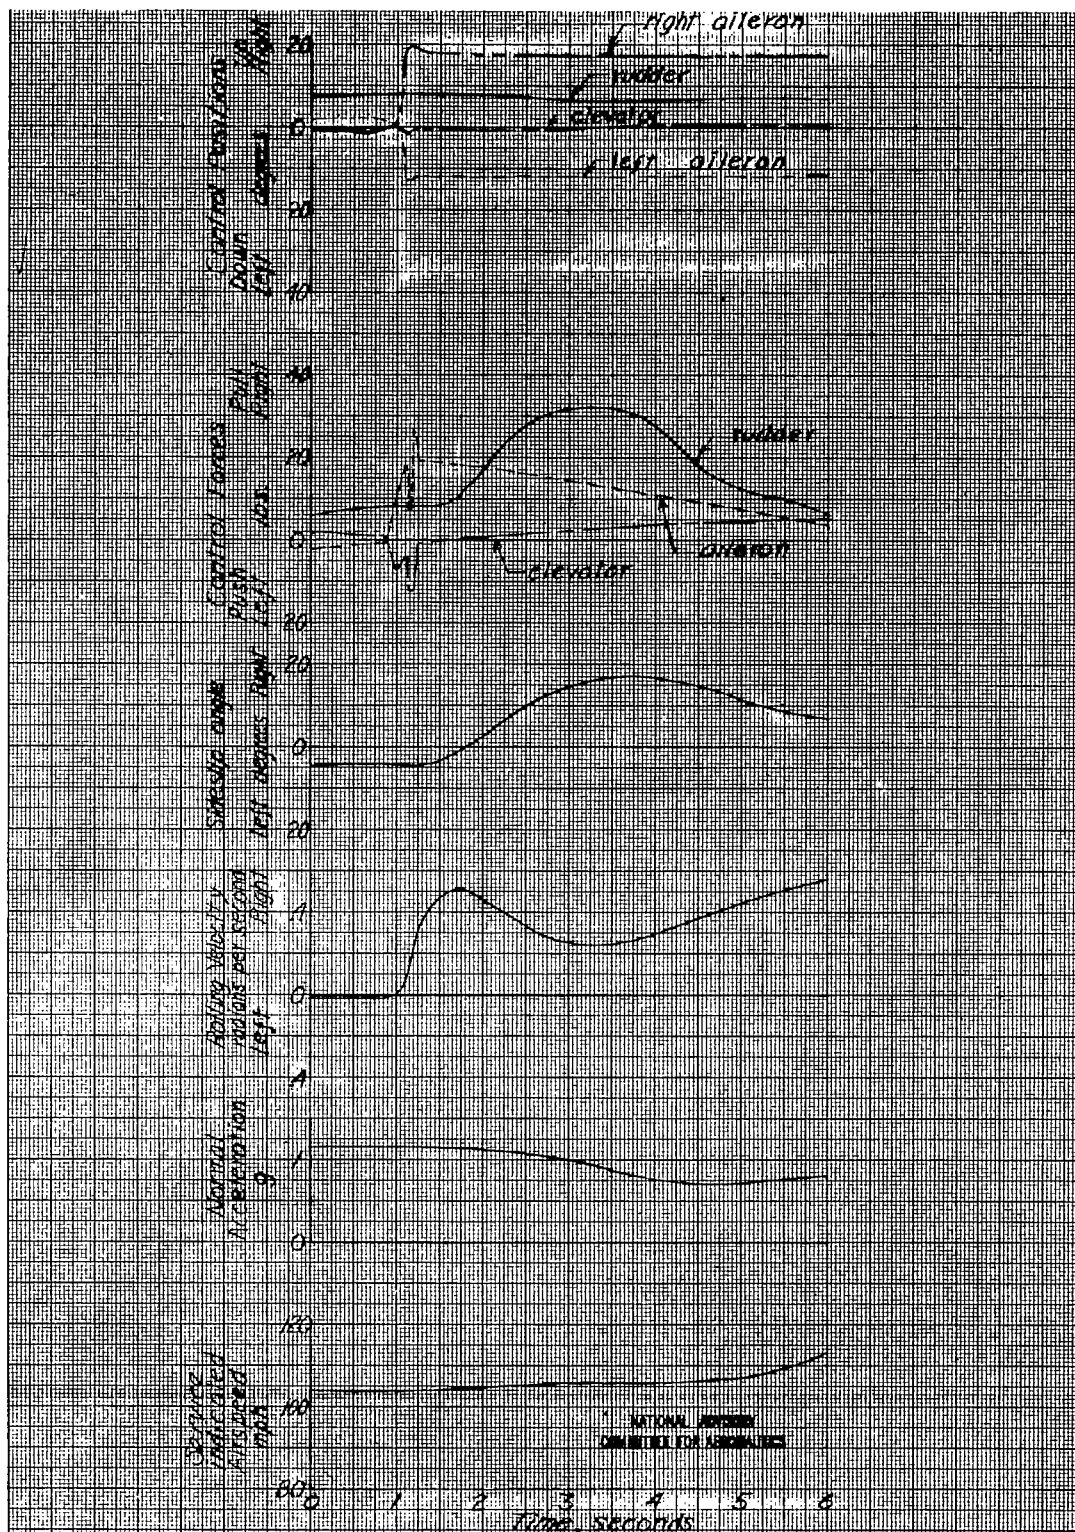
Figure 15. - Time history of rolling out of a left turn using full aileron deflection with rudder held fixed. Clean condition, power for level flight, F6F-3 airplane.

The sideslip due to ailerons was measured in the abrupt aileron rolls from laterally level flight described above and in abrupt rolls out of turns with the rudder held fixed. The latter maneuver has been adopted as standard practice at Langley for measuring sideslip due to ailerons because it has been found difficult to obtain maximum sideslip angle in a roll from laterally level flight, since the airplane usually reaches an extreme angle of bank before maximum sideslip angle is reached. In the present instance, it was possible to reach maximum sideslip angle in right rolls from laterally level flight. Figures 8 and 9 illustrate rolls from laterally level flight. Rolls out of turns are shown in figures 13, 14, and 15. Figure 16 shows the change in maximum sideslip angle as a function of change in total aileron angle in abrupt rolls made from laterally level flight at 98 miles per hour. Inspection of these figures shows that the use of full aileron deflection at approximately 100 miles per hour will result in approximately 18.5° of sideslip

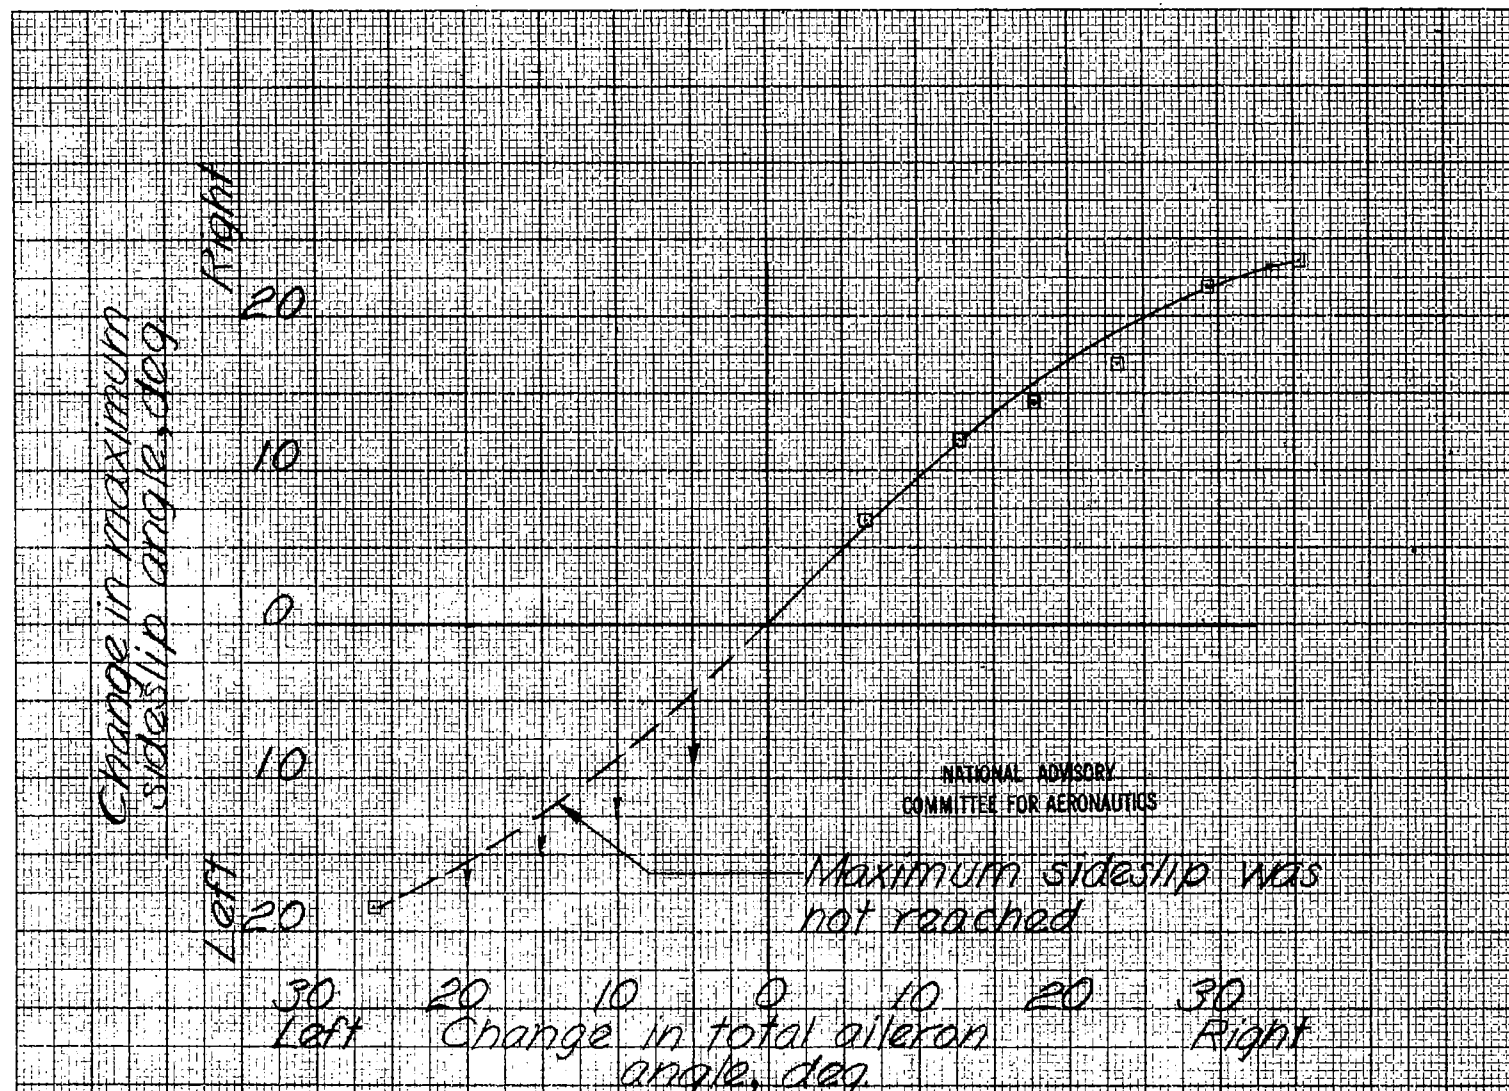
Figure 16. - Change in maximum sideslip angle with change in total aileron angle in abrupt aileron rolls made from laterally level flight at 98 miles per hour. Clean condition, power for level flight, F6F-3 airplane.

4. As shown by figures 16 to 29 right-rudder force was required to hold right-rudder deflections and left-rudder force was required to hold left-rudder deflections.

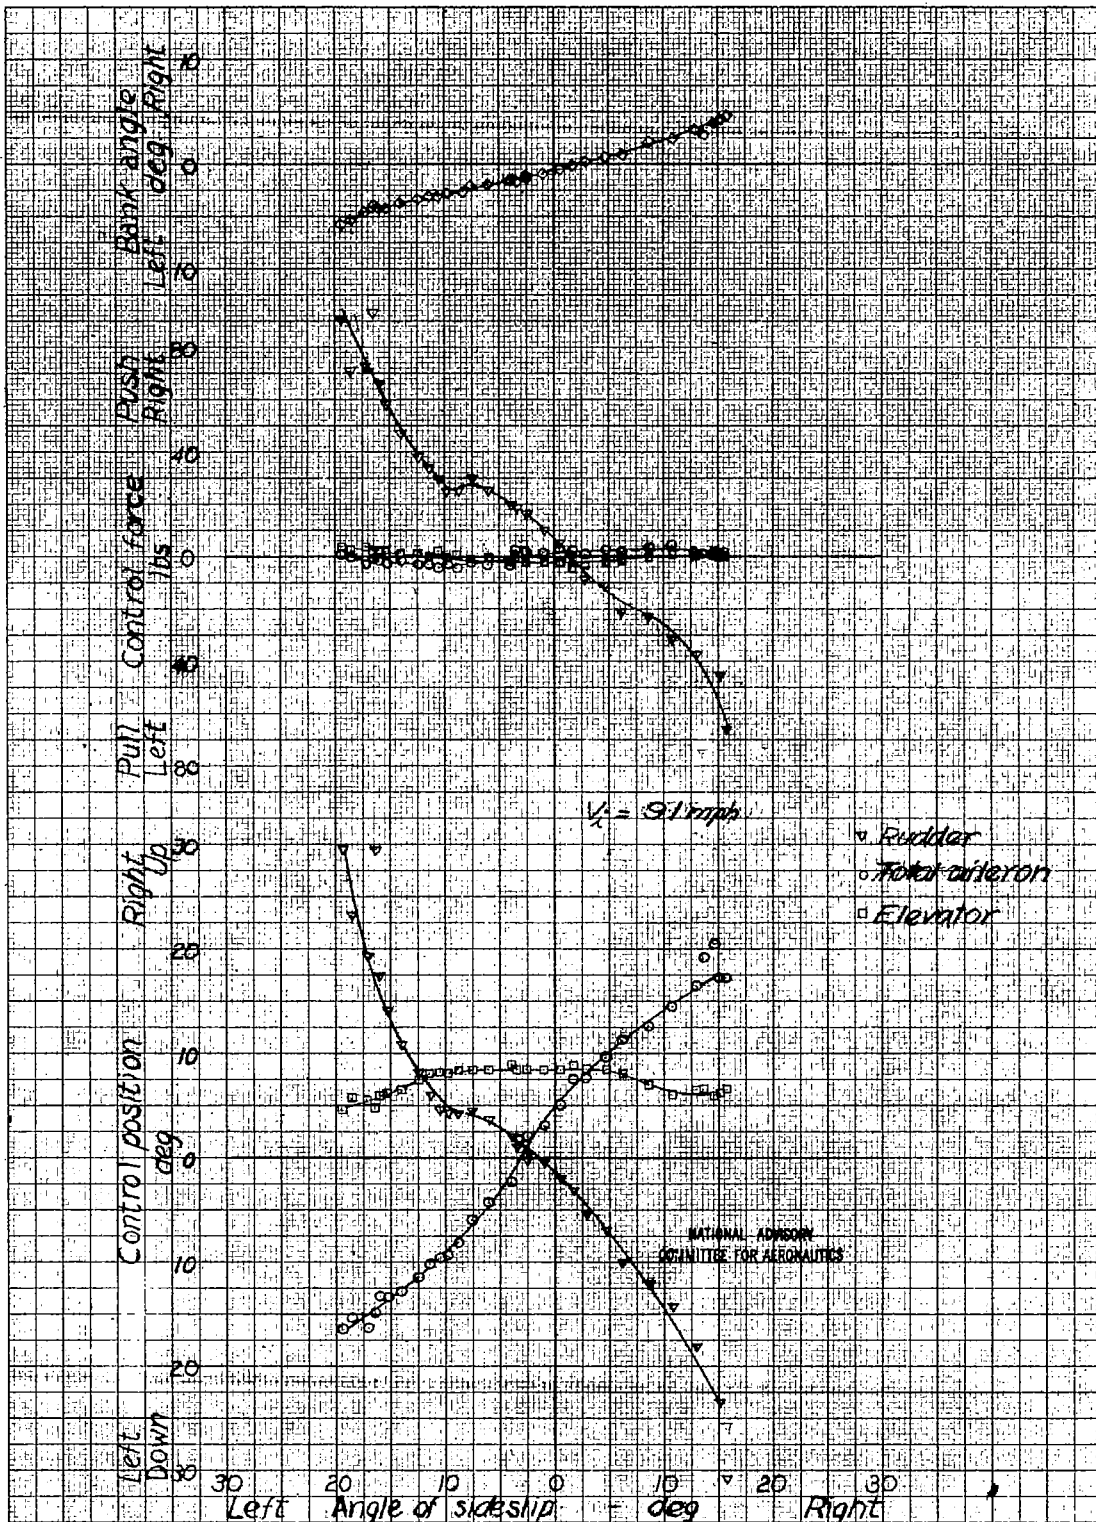
Figure 17. - Steady sideslip characteristics in the landing condition at 91 miles per hour, F6F-3 airplane.

The variation of cross-wind force with sideslip angle was in the correct direction; that is, right bank accompanied right sideslip and left bank accompanied left sideslip as shown by figures 17 to 30.

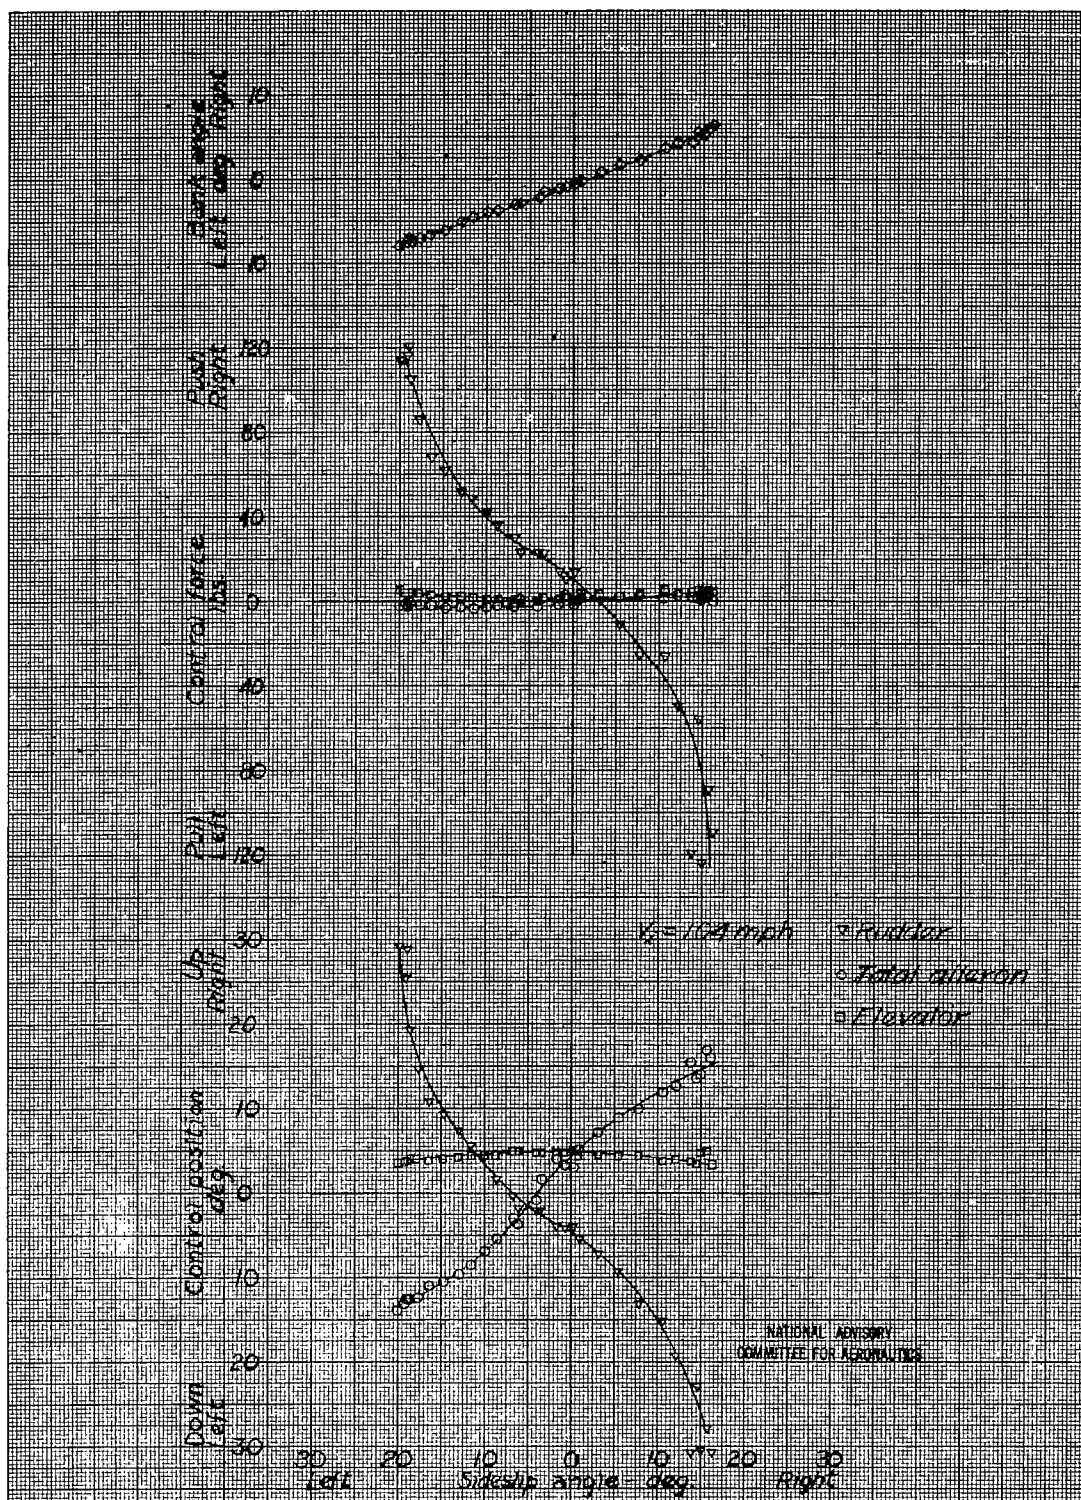
Figure 18. - Steady sideslip characteristics in the landing condition at 104 miles per hour, F6F-3 airplane.

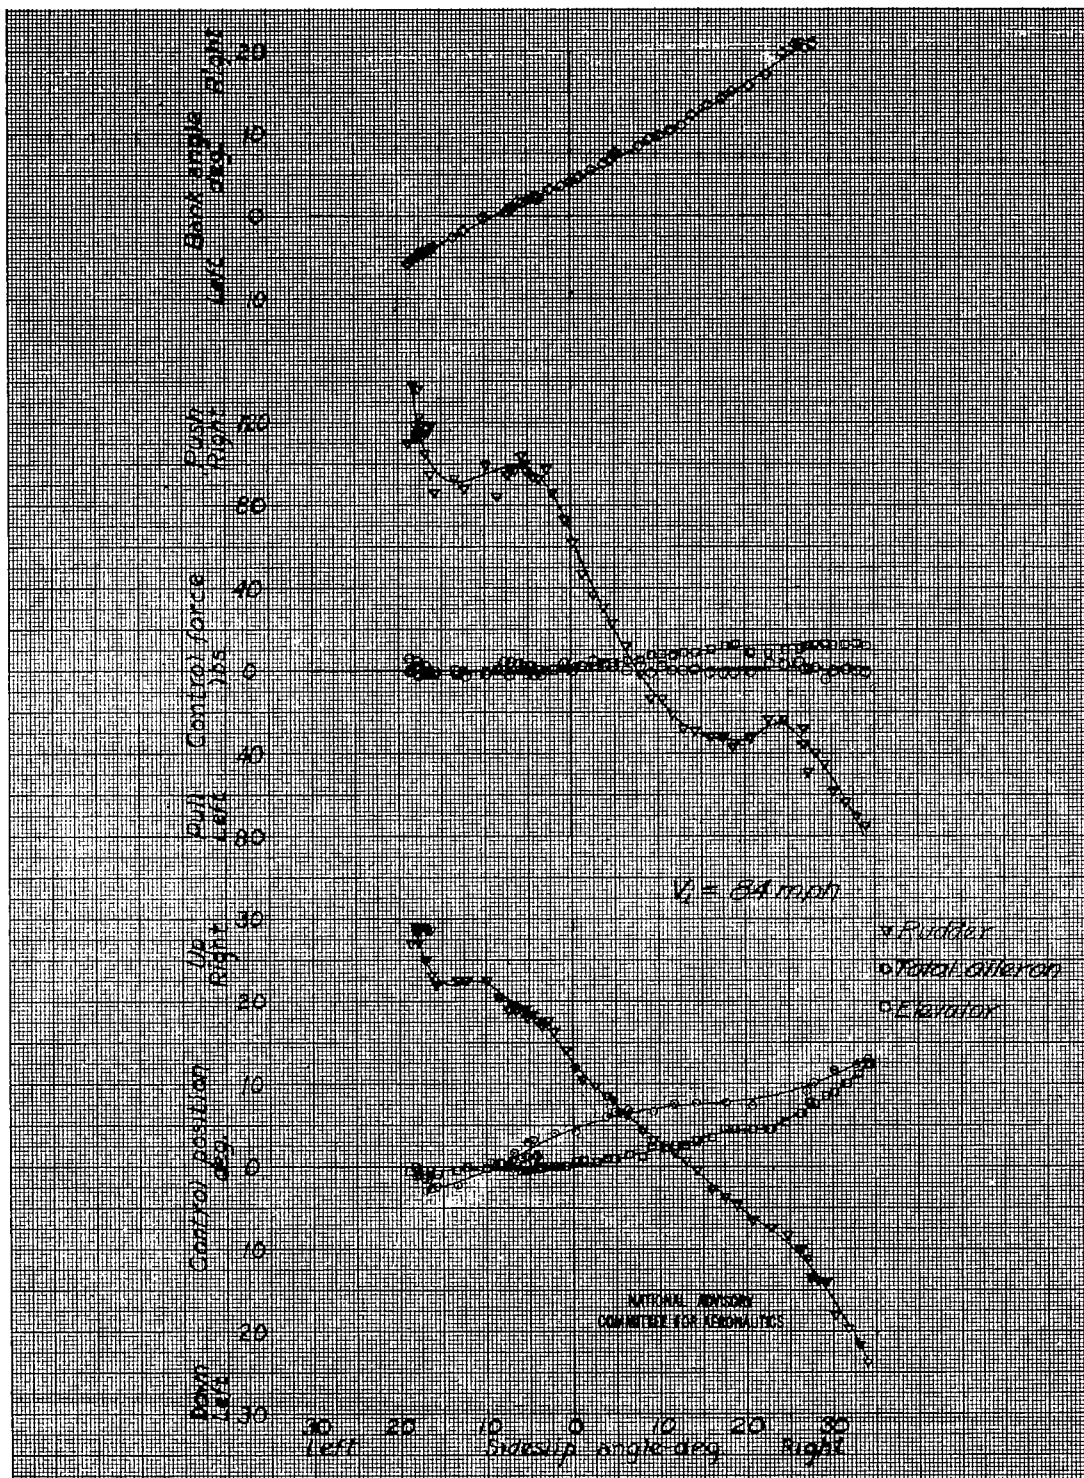
Figure 19. - Steady sideslip characteristics in the wave-off condition at 84 miles per hour, F6F-3 airplane.

3. The yawing moment due to sideslip (rudder free) was found to be such that the airplane would always tend to return to zero sideslip, regardless of the angle of sideslip to which it was forced in all conditions of flight tested. In the wave-off condition, however, there was reversal in the slope of the rudder force curves as can be seen by inspection of figures 19 and 20.

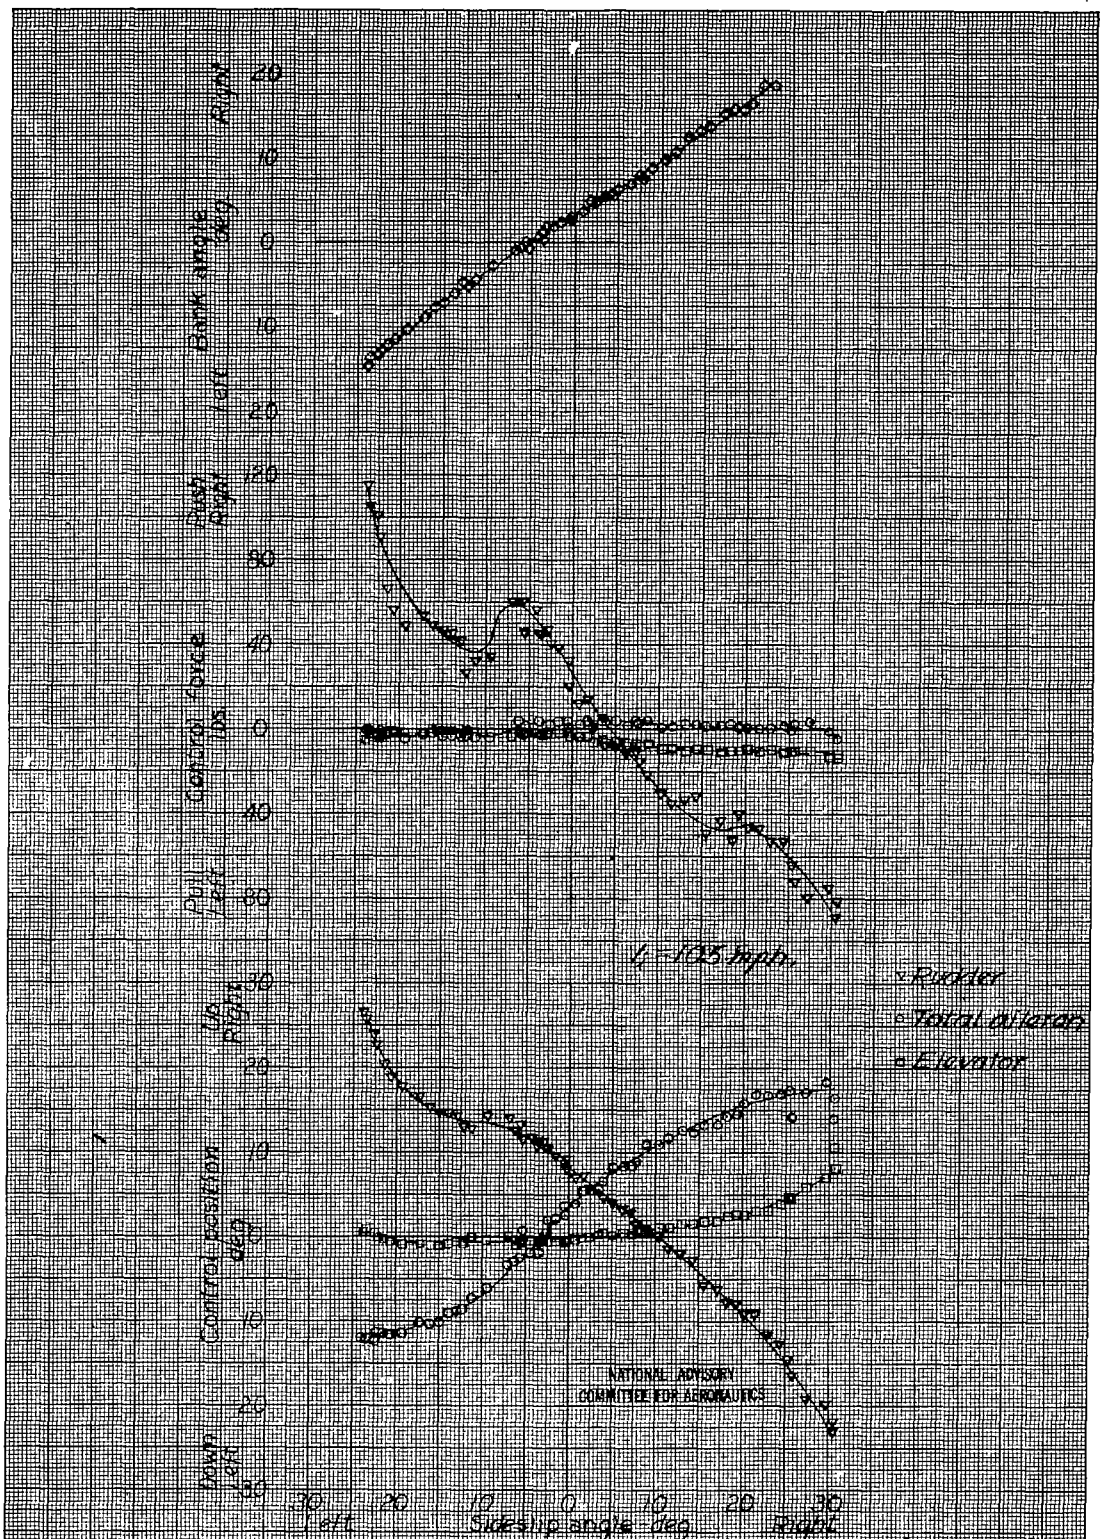
Figure 20. - Steady sideslip characteristics in the wave-off condition at 105 miles per hour, F6F-3 airplane.

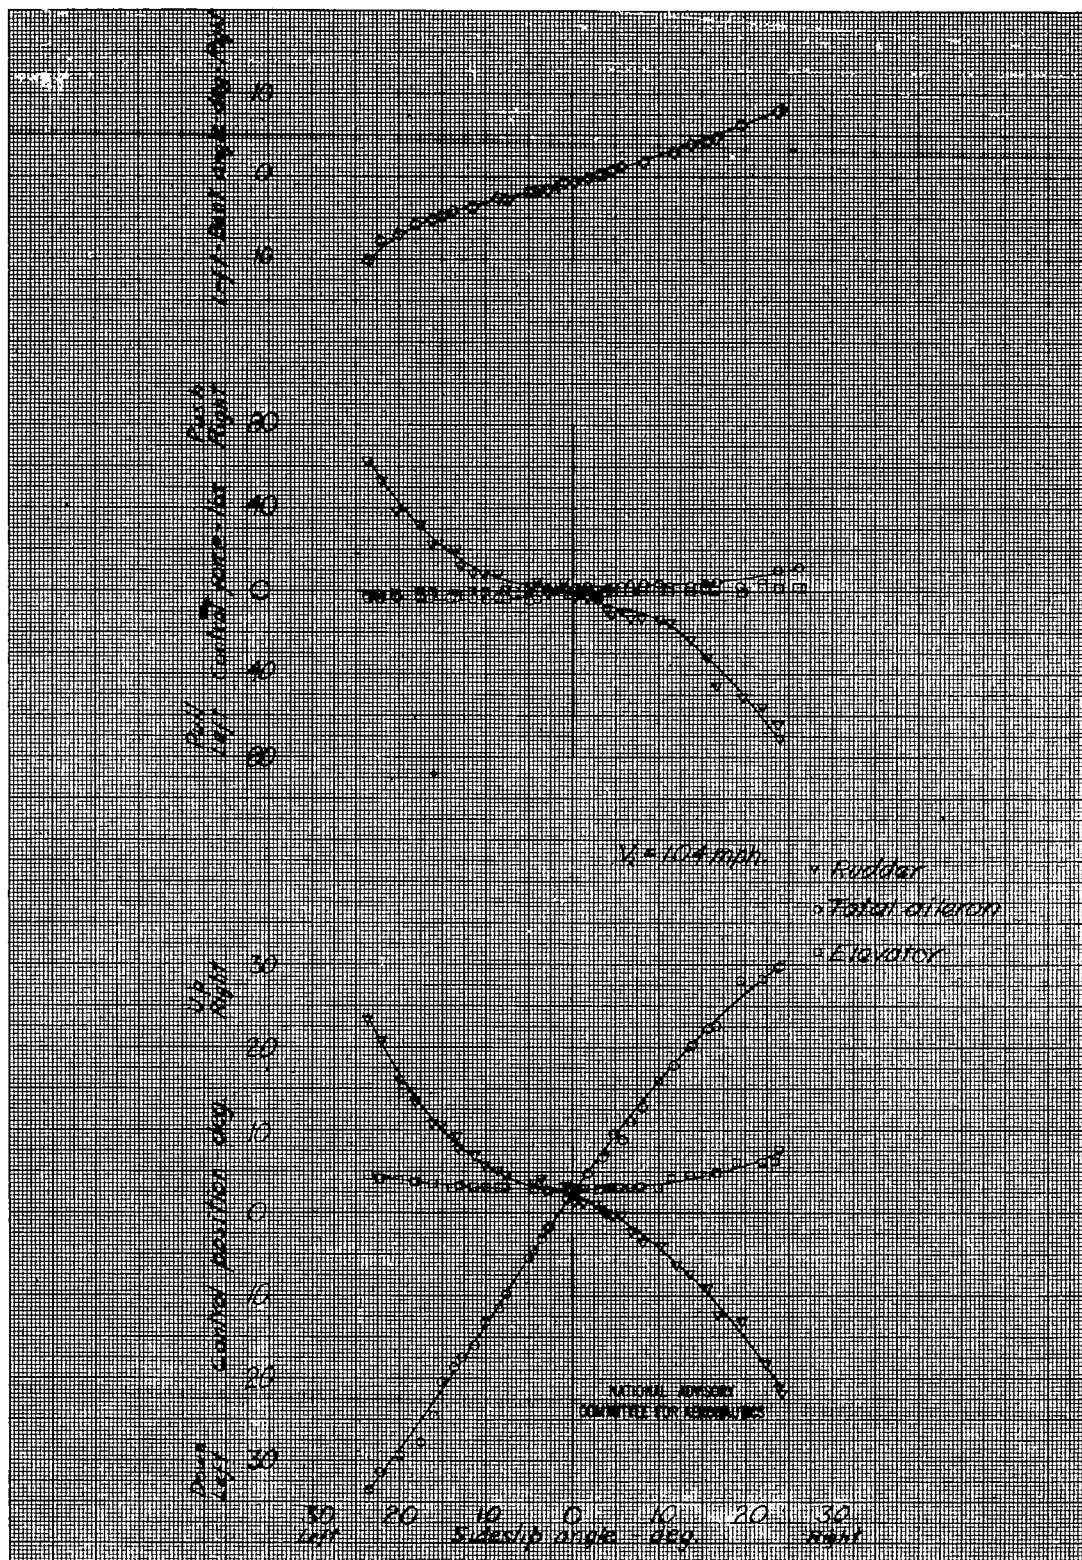
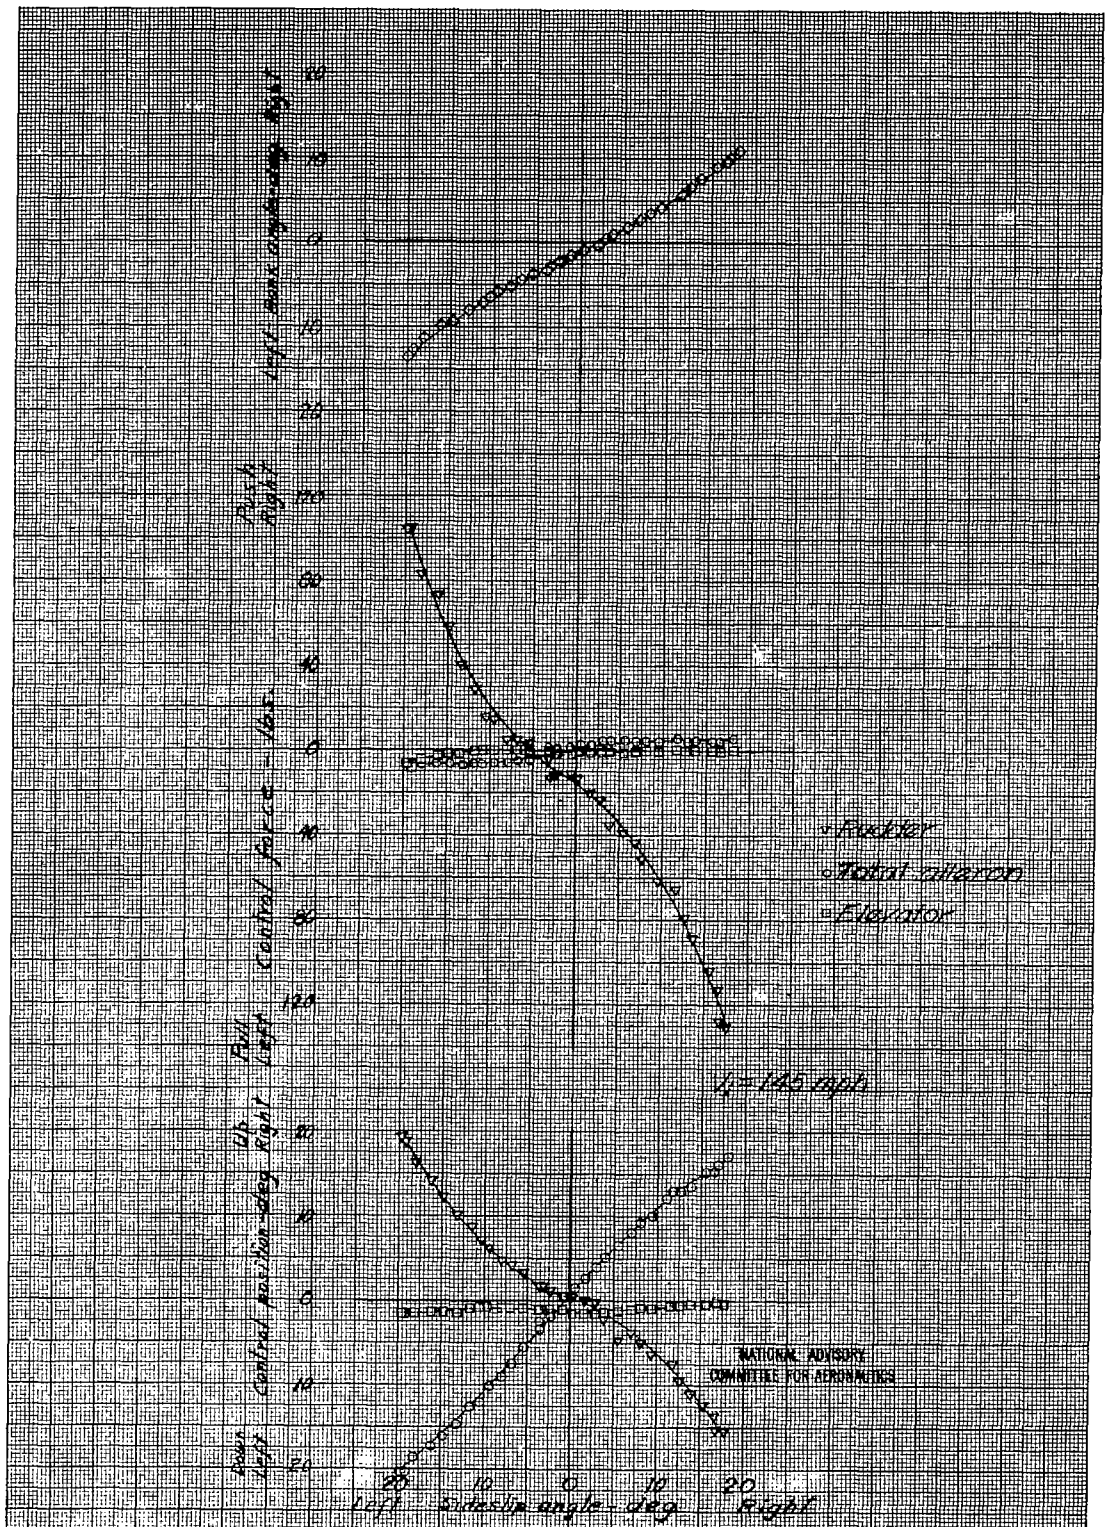
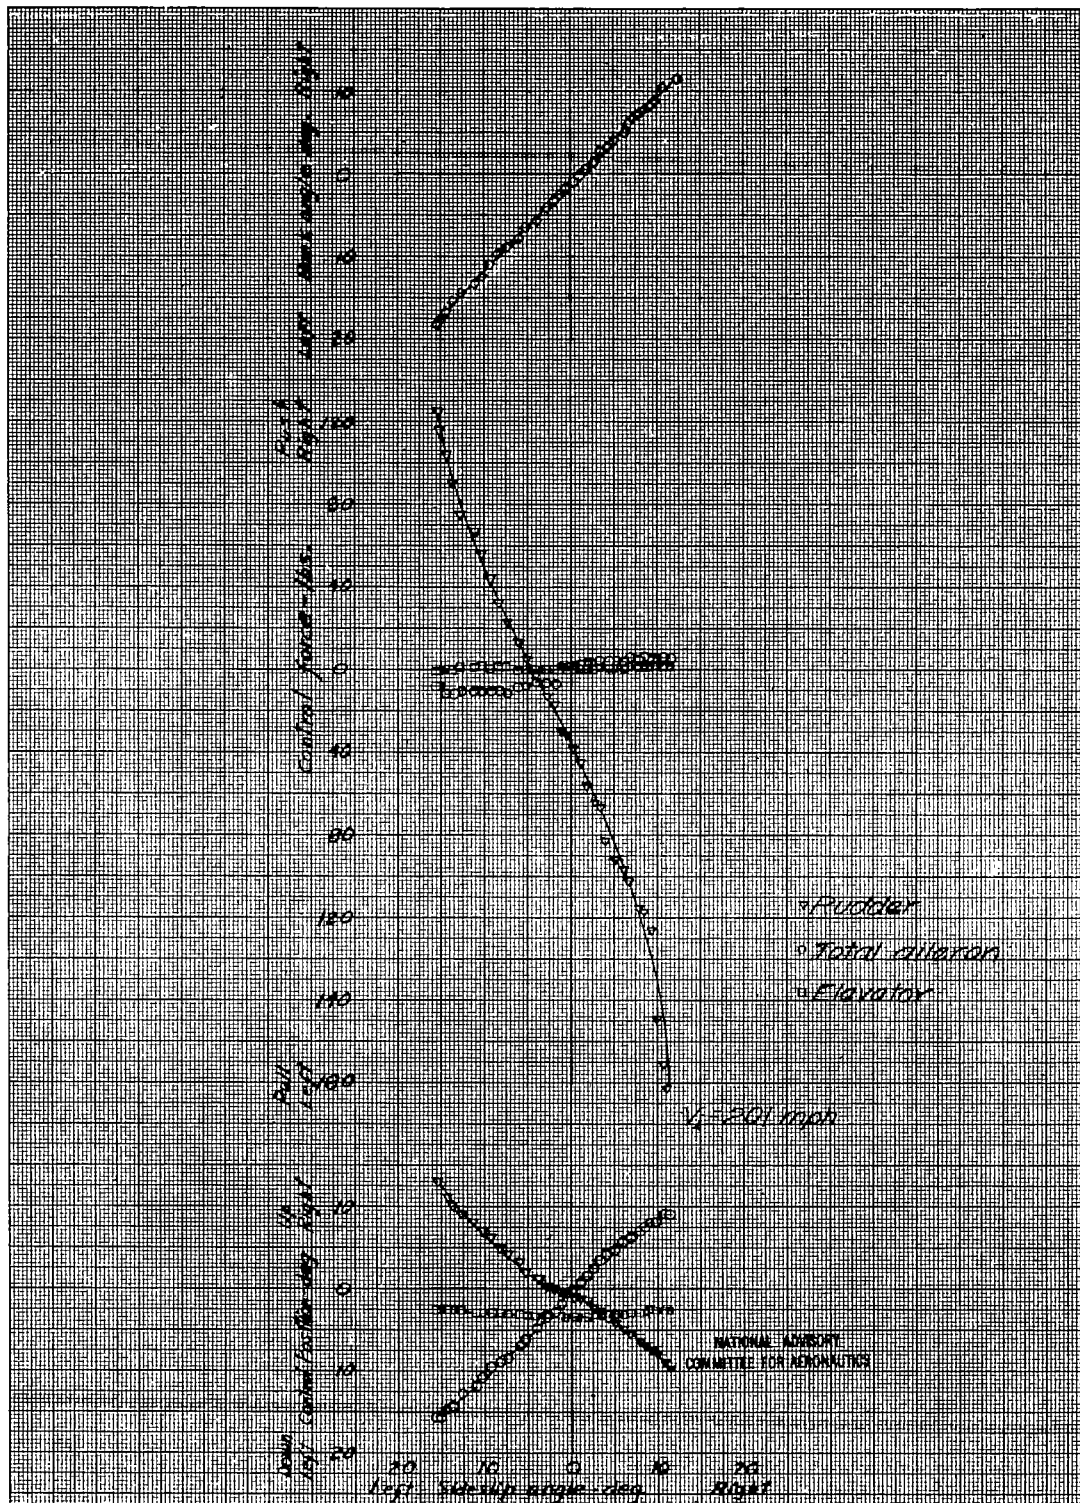
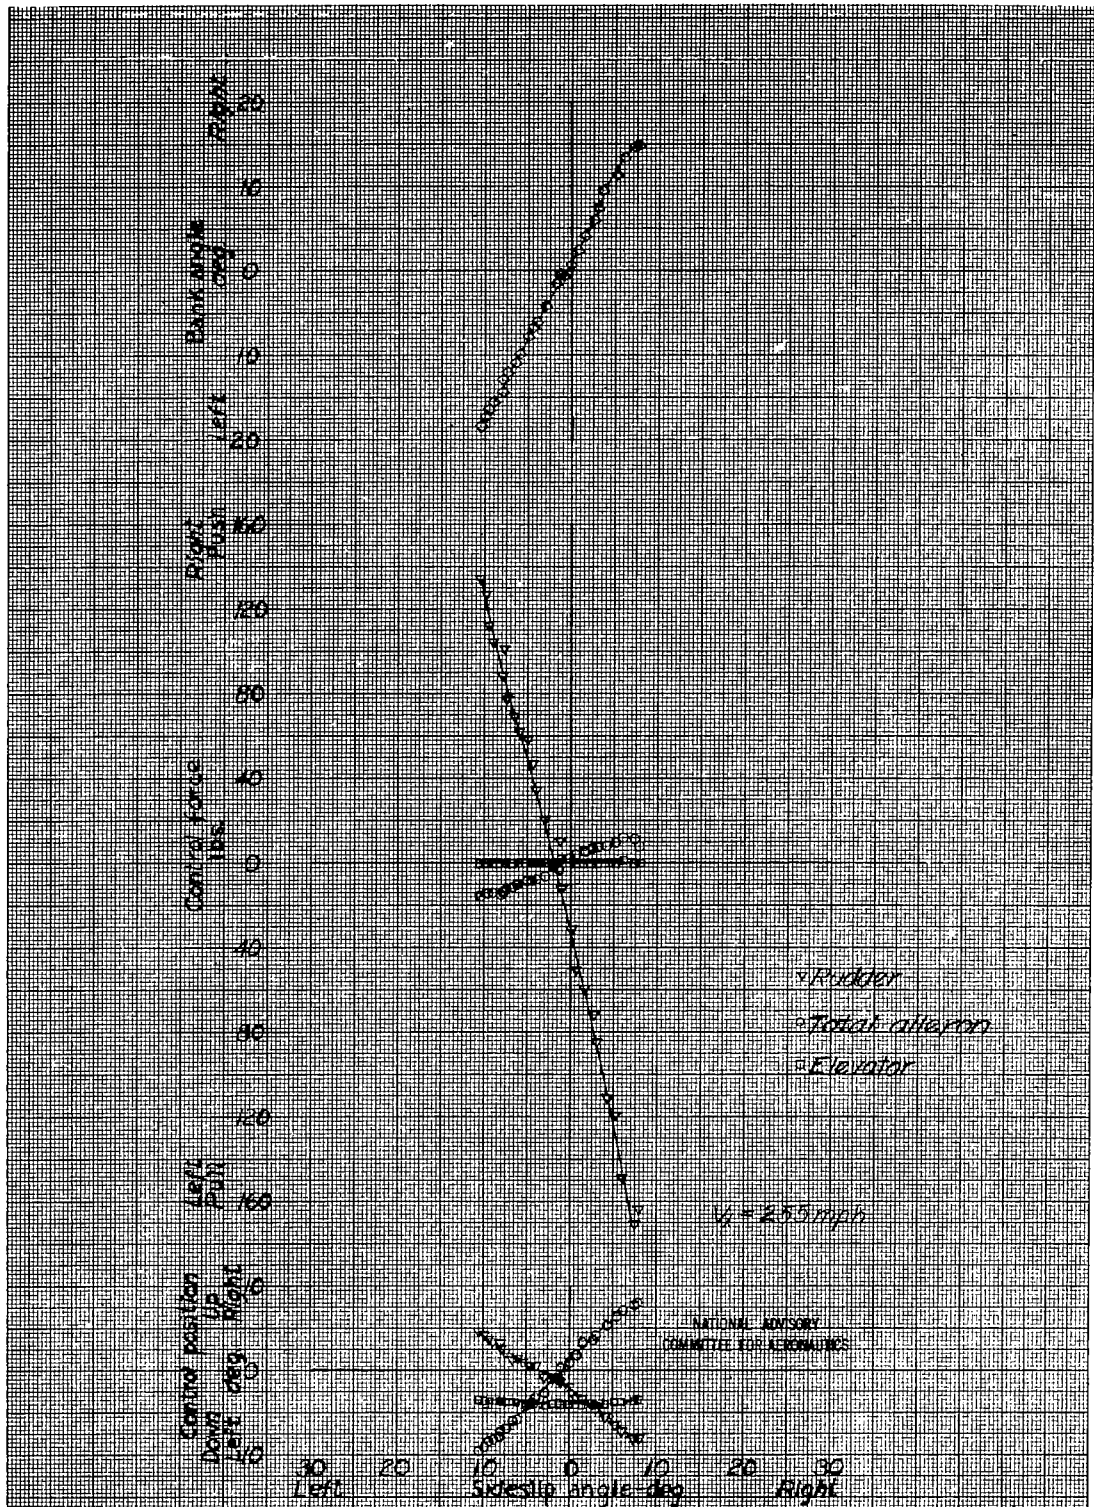
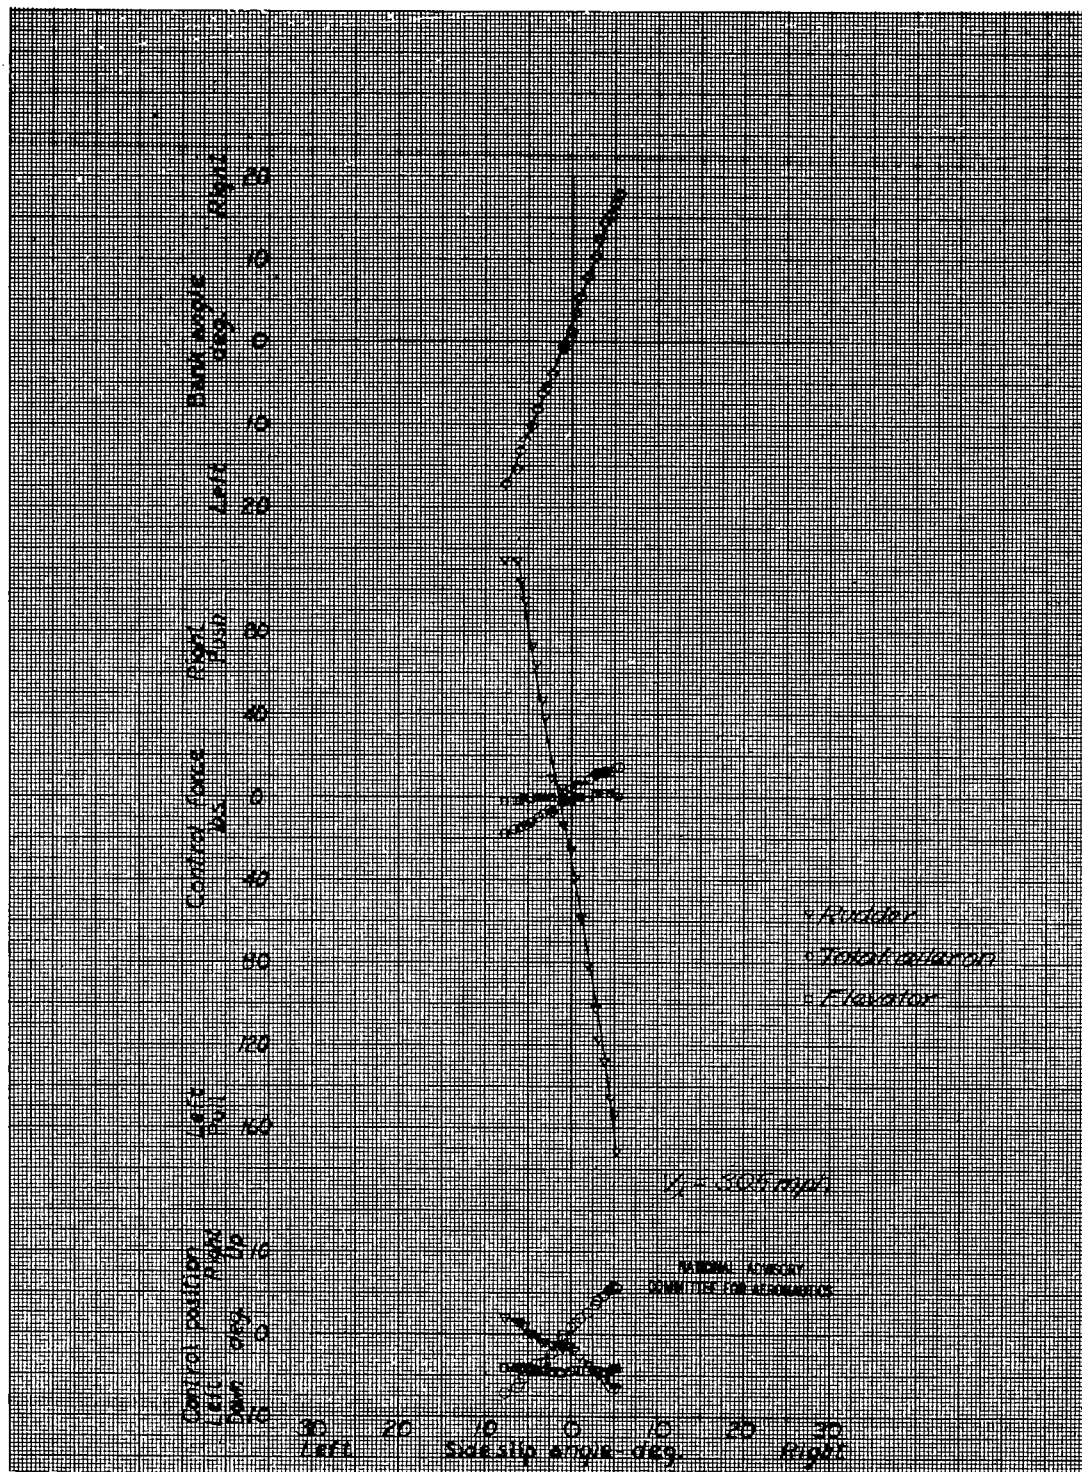
Figure 21. - Steady sideslip characteristics in the gliding condition at 104 miles per hour, F6F-3 airplane.

Figure 22. - Steady sideslip characteristics in the gliding condition at 145 miles per hour, F6F-3 airplane.

Figure 23. - Steady sideslip characteristics in the gliding condition at 201 miles per hour, P6F-3 airplane.

Figure 24. - Steady sideslip characteristics in the gliding condition at 255 miles per hour, F6F-3 airplane.

Figure 25. - Steady sideslip characteristics in the gliding condition at 305 miles per hour, F6F-3 airplane.
